# Key Emerging Issues and Recent Progress related to Structural Materials Degradation (PWRs, VVERs and CANDUs)

A.N.T. INTERNATIONAL®

© December 2015

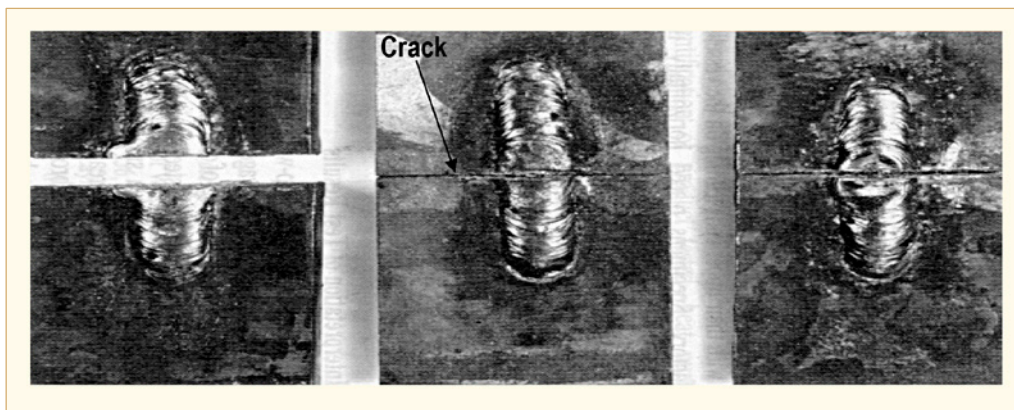
Figure 2-3: View of cracked Pellini specimens.

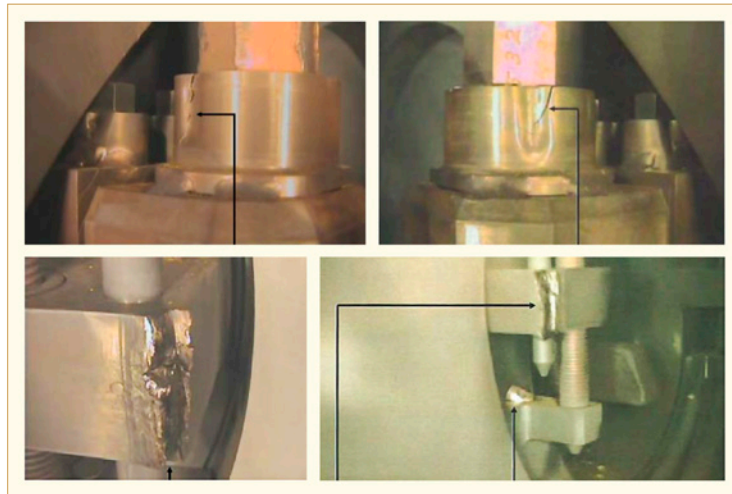
Replacement of the vent valve and the lack of any significant degradation observed on the remaining component items provide confidence that the RV internals will be able to perform their safety-related functions during the period of extended operation (Figure 4-3).

Figure 4-3: Visual examination video capture of the ONS-2 core support shield vent valve. Top left: jackscrew locking crimp cup indication, item #1. Top right: jackscrew locking crimp cup indication, item #2. Bottom left: body impact damage. Bottom right: body impact damage and barrel nut incorrect positioning.

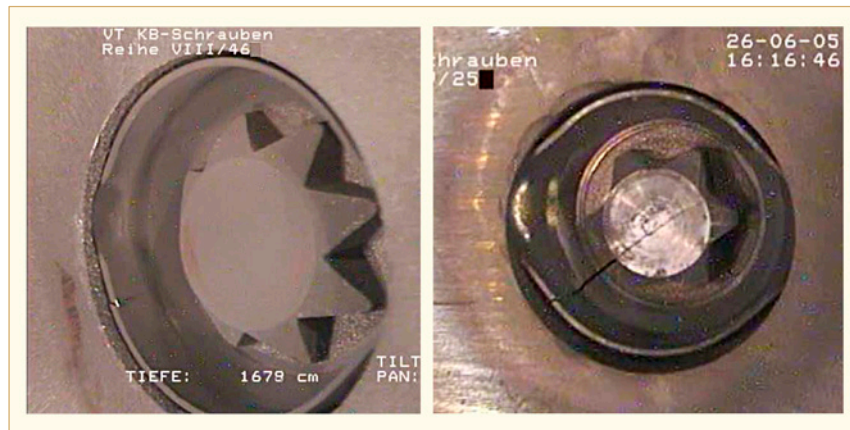
In 2005, during a recurring in-service inspection (visual inspection) of the core barrel bolts in a German PWR, crack like indications were detected on four barrel bolts, (see Figure 5-3). The bolts, known as star bolts, are made of SS type 316 Ti (German material # 1.4571) bars, which are cold worked to adjust the required mechanical properties. In the following due to additional inspection all six operating Siemens/KWU PWR plants with mounted core barrel and star bolts were affected. Therefore a research program was launched by AREVA and VGB to systematically investigate the root cause of these failures. Beside laboratory investigations of cold worked austenitic stainless steel under PWR primary environment, engineering work was initiated to compile and analyze the data from field experience. The reference [Kilian et al, 2014] presents the results of the engineering work.

Figure 5-3: Crack like indication on a barrel bolt. Left: in the area of cup preventing unintentional loosening. Right: crack initiation in the head.

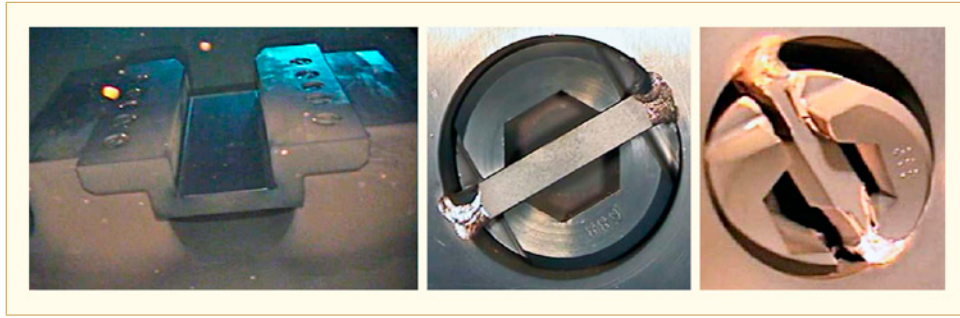
Mating radial keys are installed on the core barrel, which interface with the clevis inserts when the lower internals are installed. The original clevis insert bolts are socket head cap screws with a slot in the head to accommodate a welded lock bar. Underwater images of a clevis lug, clevis insert, broken bolt, and intact bolt taken during the March 2010 inspection are presented in Figure 6-2. The clevis bolts were fabricated from Alloy X-750 (UNS N07750) material. The reported heat treatment for the bolts included a low solution annealing temperature (<982°C) and a two-step aging treatment. Alloy X-750 material heat treated in this manner is known to have poor resistance to IGSCC in both high and low temperature primary water. A minimum pattern of clevis bolts was replaced in all six clevis inserts during the spring 2013 Unit 1 refueling outage, including all with visual indications. A total of 29 clevis bolts – 16 broken and 13 intact – were removed from the LRSS. Broken bolts, or a combination of broken and intact bolts, were removed from four of the six clevis inserts, while bolts removed from the remaining two clevis inserts were all intact. All 29 bolts were shipped to the Babcock & Wilcox Lynchburg Technology Center for comprehensive laboratory analysis and testing [Hyres et al, 2014].

Figure 6-2: Underwater images of clevis lug and insert plate (left), intact bolt (middle), and broken bolt (right).

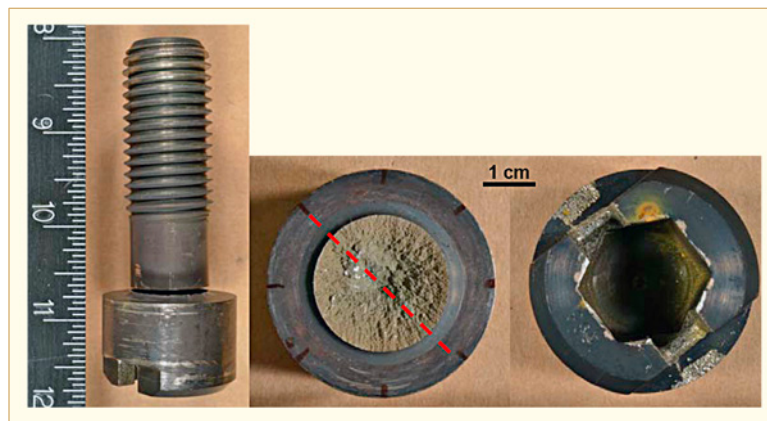
Stereomicroscope examination of the fracture surfaces on the broken bolts identified multiple crack initiation locations around the bolt circumference at the head-to-shank transition. Most of the bolt fracture surfaces exhibited a clear axis of symmetry, as shown by the dashed red lines in Figure 6-3. The symmetry appears to be the result of two diametrically opposing crack fronts propagating toward each other before linking up near the center of the bolt section. For each bolt, the orientation of the axis of symmetry was compared with the location and orientation of each bolt within the clevis insert plates, and no correlation was found. This suggests that the stresses driving crack initiation and propagation were predominantly from the bolt installation preload, and not from forces on the bolts during plant operation (e.g., thermal expansion, bending) or the result of a non-perpendicularity of the bolt seating surfaces with respect to the bolt holes in the insert plates.

Figure 6-3: Bolt 120°-6 side view (left), open fracture showing lighter macro appearance (center), and opposite side of head (right). Bolt head photos match in-service position.

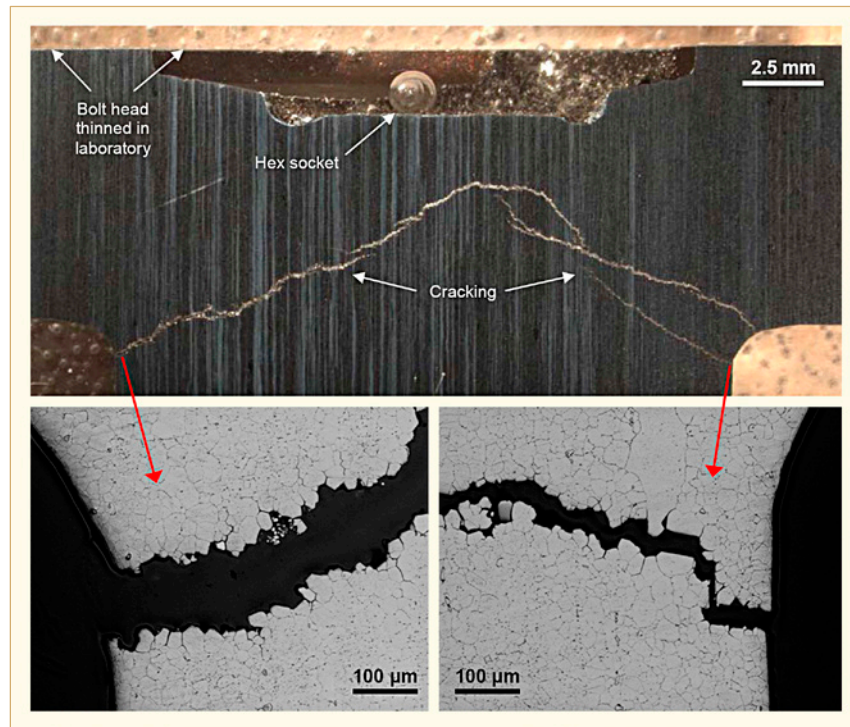
Optical and SEM metallography of the four selected bolts showed that multiple intergranular cracks, typical of IGSCC in PWR primary water, initiated around the circumference of each bolt at the head-to-shank transition and propagated inward toward the bottom of the hex socket (Figure 6-4 top). The resulting crack surface formed was conical with the conical plane at approximately 35° to the bolt seating surface. The crack initiation and propagation direction coincided with maximum local tensile stress in the area. Cracking exhibited a branched intergranular morphology in all areas examined (Figure 6-4 bottom).

Figure 6-4: Top: 240°-7 bolt head cross section showing banded microstructure; bottom: close-up of intergranular cracking in the head-to-shank transition areas.

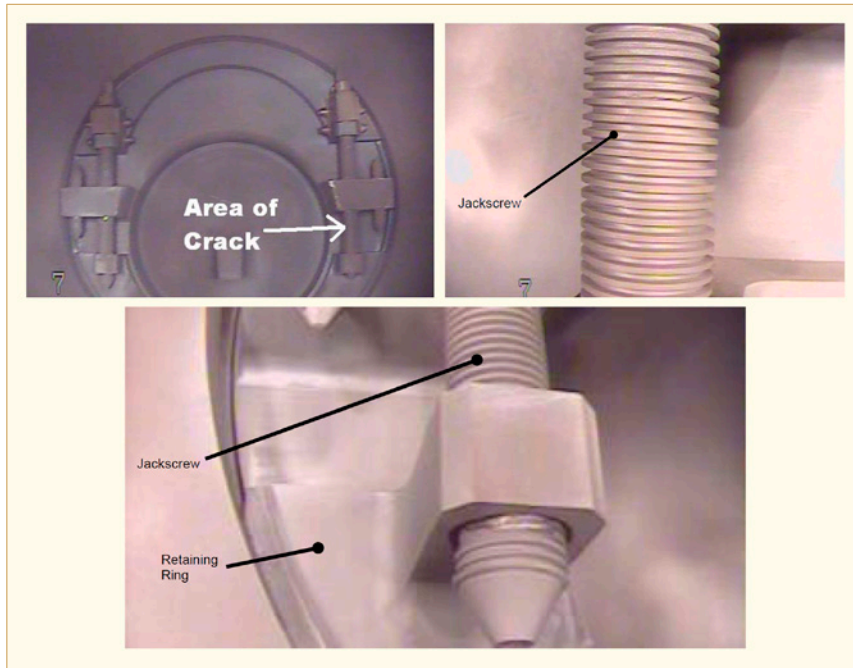
Figure 7-2: Visual examination video capture of ONS-1 CSS vent valve and detail of jackscrews prior to removal. Top left: overview. Top right: right (as viewed from inside of CSS) jackscrew. Bottom: left (as viewed from inside of CSS) jackscrew.

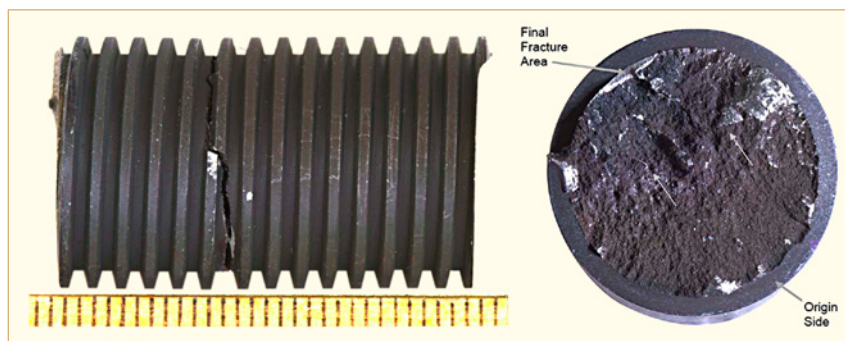
Three jackscrew remnants were received at the lab, including two short sections bounded by the mating fractures and EDM cuts on the opposite ends. The jackscrew remnants were covered with a dark, black oxide (see Figure 7-3 left). The fracture profile exhibited a blocky, brittle appearance and generally followed the root of the thread form with the exception of one location where the fracture ran across a thread crest (see Figure 7-3 left). The mating fracture surfaces were largely covered with a similar dark, black oxide, although a very small crescent-shaped final fracture zone with a fresh, ductile appearance was observed on one side of the screw (see Figure 7-3 right). Ratchet lines and faint arced crack front markings were visible, which were consistent with the crack having initiated on the side of the screw opposed to the final fracture zone (see Figure 7-3 right). Additionally, the origin-side of the fracture surface was stained slightly darker than the side containing the final fracture.

Figure 7-3: Cracked ONS-1 CSS vent valve jackscrew, as-Received. Left: 90° orientation. Right: overview of one mating surface.

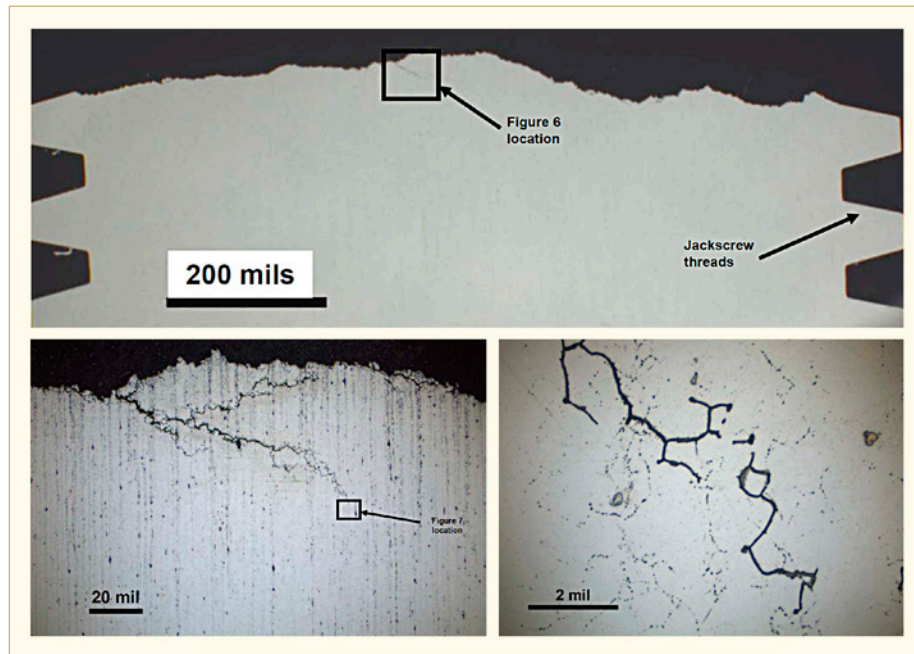
A longitudinal metallographic section was taken through the fracture at the origin (see Figure 7-4); review of this metallographic section confirmed that the crack mode was intergranular (see Figure 7-4). Some secondary branching was observed and these cracks were also confirmed to be entirely intergranular (see Figure 7-4). The grain boundaries were decorated with carbides, although there was evidence of an intragranular carbide network as well, possibly from incomplete dissolution of carbides that had outlined the grain structure existing prior to solution treatment. The grain size was relatively fine (estimated to be about ASTM No. 7) and axial deformation bands, suggestive of small amounts of residual cold work, were observed across the jackscrew diameter.

Figure 7-4: Cracked ONS-1 vent valve jackscrew; longitudinal metallographic section taken through jackscrew showing closer view of intergranular branching (oxalic acid etch).

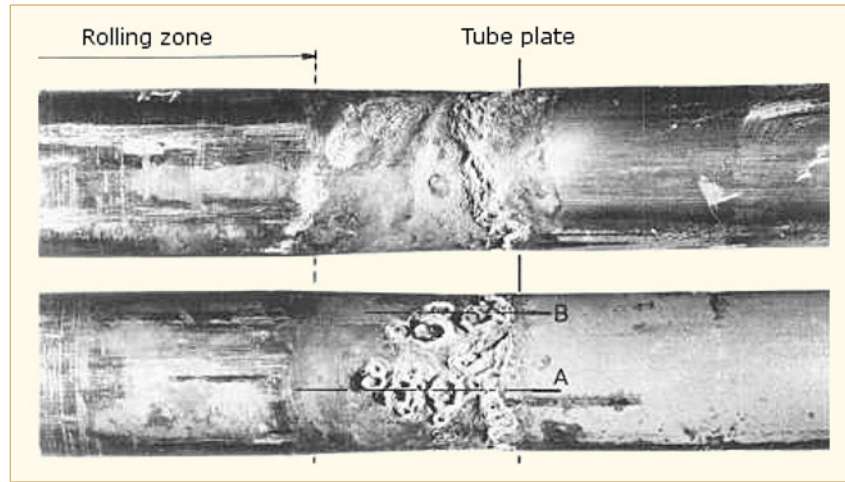
Historically, this degradation has been observed on the oldest 3-loops plants, which were equipped with SS tubes. SS tubes being prone to caustic corrosion (Figure 9-1), these tubes have been replaced with LAS tubes which are less susceptible. Also, full depth rolling has been implemented on new exchangers. However, LAS tubes can also suffer from caustic corrosion (Figure 9-2) in the hottest areas of the bundle (close to the hot channel head).

Figure 9-1: View of a SS tube suffering from OD caustic corrosion (1986). Non-regenerative heat exchanger of a 3-loop unit.

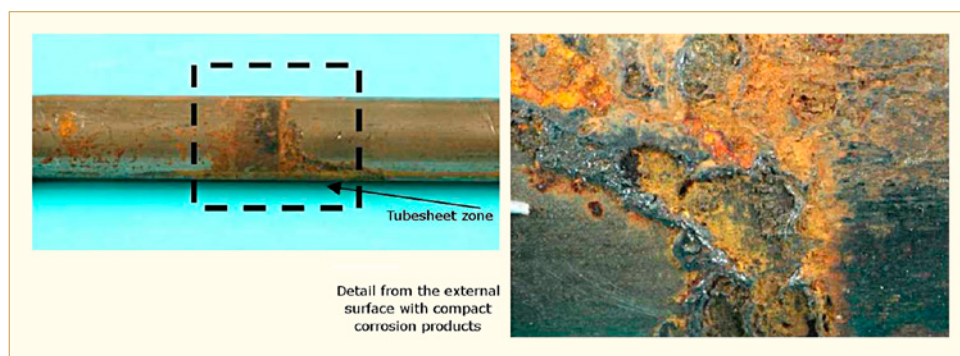
Figure 9-2: View of a LAS tube suffering from OD caustic corrosion (2006). Non-regenerative heat exchanger of a 3-loop unit.

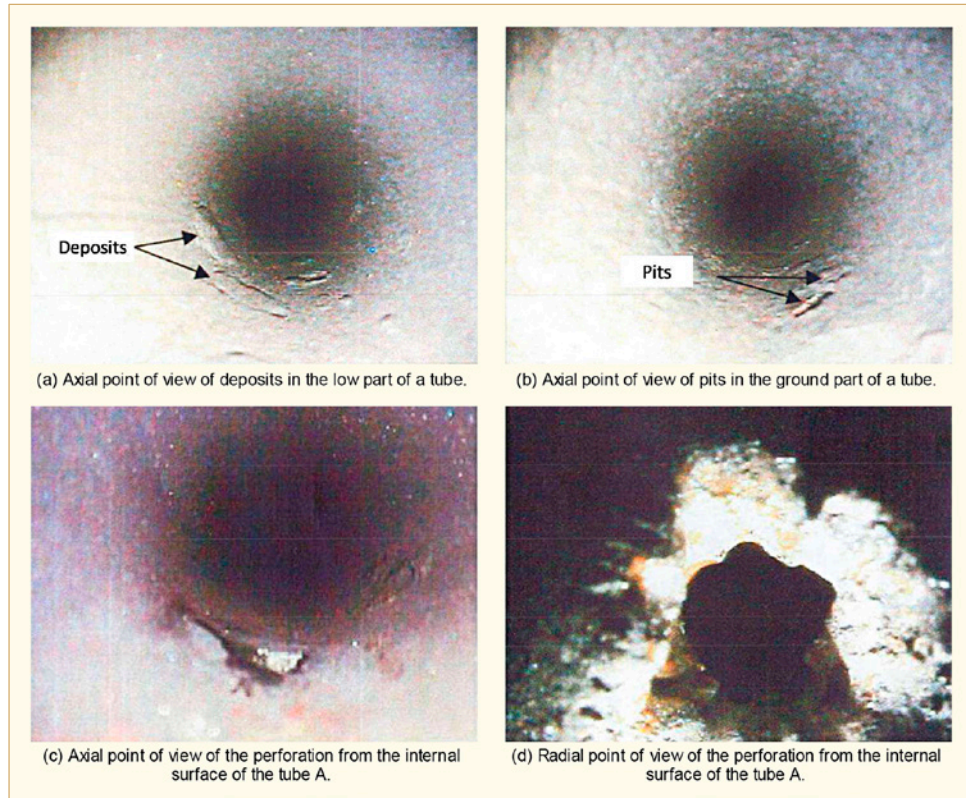
The tubes ID can experience pitting and under deposits corrosion or differential aeration corrosion (Figure 9-3). Indirect attack can also occur because of the fluid turbulence associated with the flow over and around the deposits or resulting crevice. This kind of corrosion is always located around the bottom of the tubes and associated with an inappropriate layup. As shown on Figure 9-4, the corrosion is ID initiated and can be TW.

Figure 9-3: View of the ID of tubes from a regenerative heat exchanger of a 4-loop unit. Pictures from outage VT.

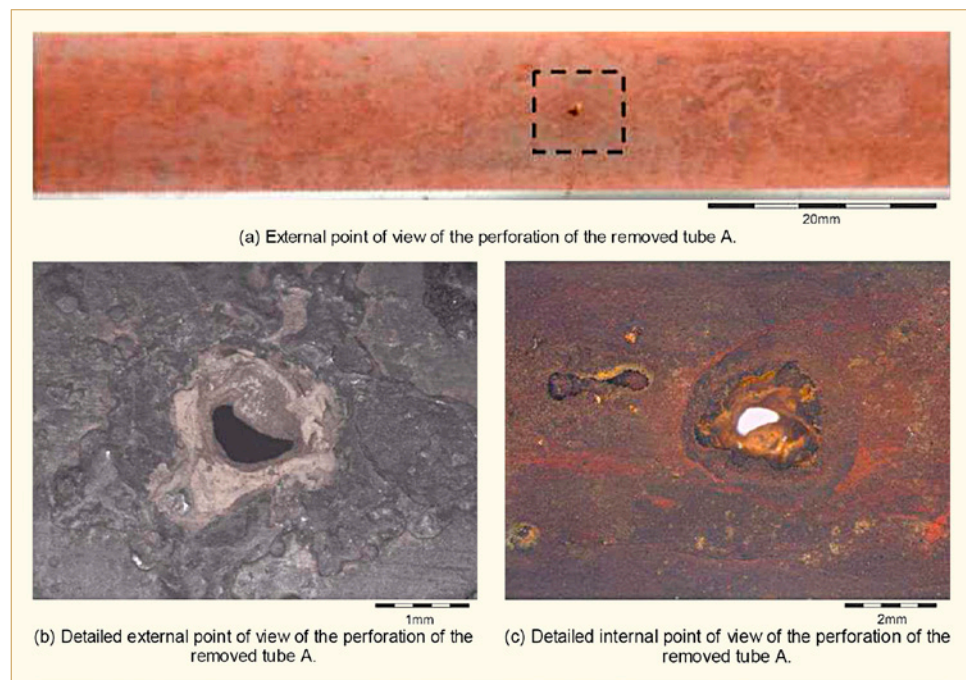
Figure 9-4: Views of a leaking tube from a regenerative heat exchanger of a 4-loop unit. Pictures from outage VT.

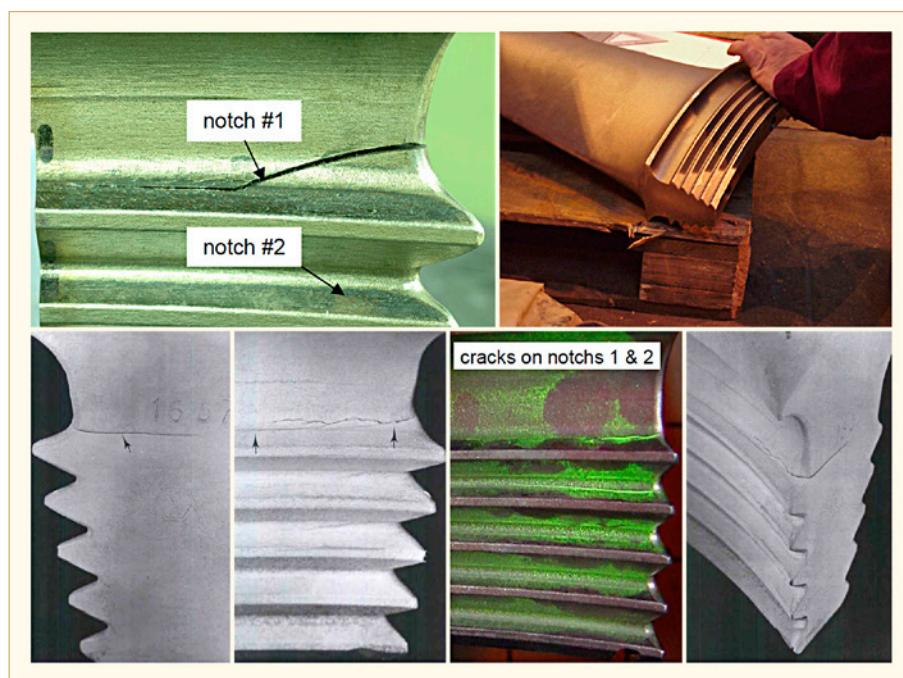
Based on the feedback of non-EDF nuclear steam turbines, nondestructive testing was added to the maintenance program since 1996: over the 12,320 LSB of the fleet, only 5 cracked blades were found. Cracks were located at the notch #1; one blade had also an atypical crack on the notch #2 (Figure 10-2).

Figure 10-2: Example of cracking of last LP stage blade.

To prevent the growth of cracks, one solution consists in reducing the level of vibrations. This can be achieved either by optimizing the natural mistuning of the blades but requires initial data such as the original blades and previous blades vibrations measurements (not available), or by imposing a forced mistuning which appears to be a better industrial solution. EDF decided to do an experiment on one LP module by permuting 4 specific blades in order to reduce the highest blade vibration level (i.e. blade #14, see Figure 10-3). As shown in Figure 10-4, this experiment gave satisfactory results with a significant reduction of the blades vibration.
