# ZIRAT-11 SPECIAL TOPIC REPORT

## **Pellet-Cladding Interaction (*PCI* and *PCMI*)**

**October, 2006**

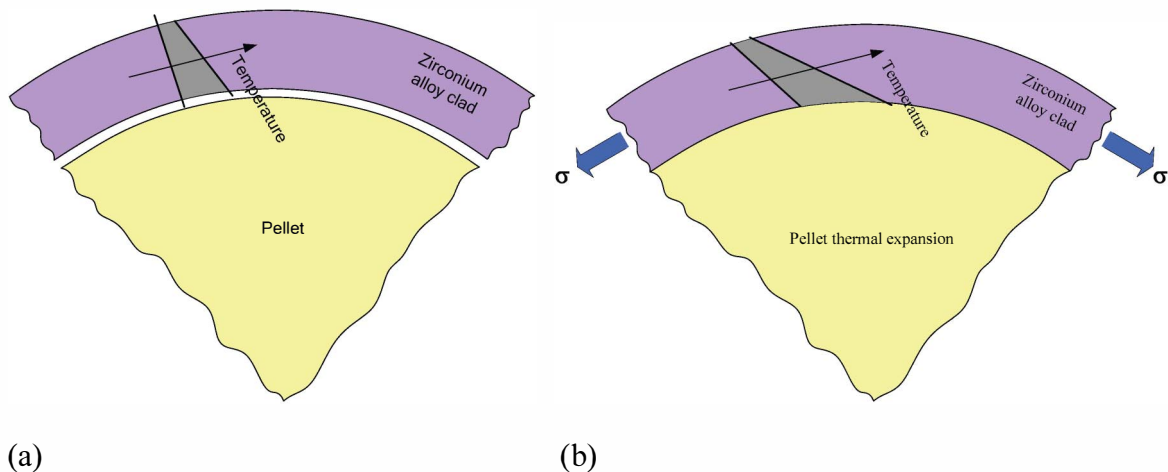
Figure 1-1: Schematics showing the fuel rod condition, (a) before the ramp and, (b) during the ramp.

**Pellet Cladding Interaction, *PCI***, is associated with local power ramps during reactor startup or manoeuvring (e.g., rod adjustments/swaps, load following), Figure 1-1, and occurs under the influence of I, Cs and Cd in a susceptible material that may result in Stress Corrosion Cracking, *SCC*, of the fuel cladding, Figure 1-2. The crack always starts at the cladding inner surface and progresses towards the outer cladding diameter in the minute scale, Figure 1-3 and, Figure 1-4. The *PCI* failure mechanism is described in Section 2.1.3.

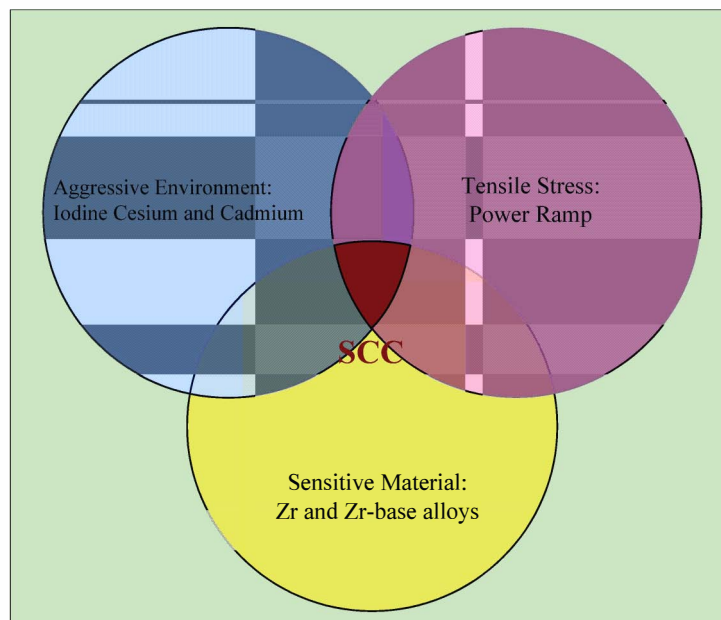
Figure 1-2: Schematics showing the three components involved in *SCC*.

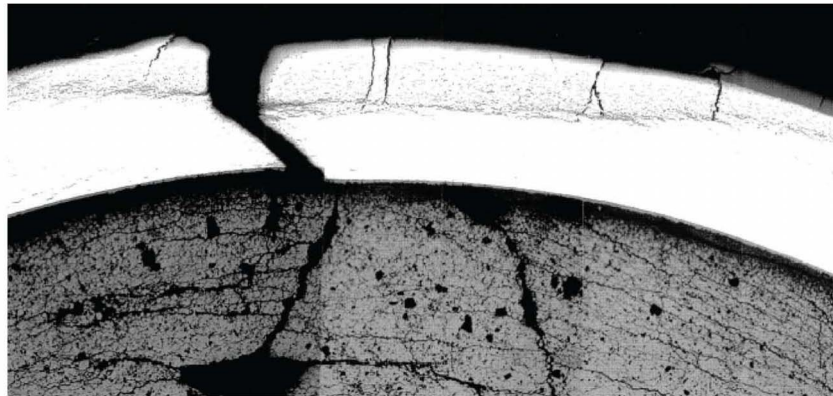
Figure 1-13: Cladding failure initiated at a hydride blister in the CABRI REP Na-8 pulse reactor test, Papin et al., 2002.

From other pulse reactor tests it has been shown that *PCMI* cracks may be initiated at the cladding outer surface due to the existence of a hydride rim reducing cladding ductility. Some of these incipient oxide cracks also propagate through the oxygen- and hydrogen-rich material just beneath the oxide. This subjacent material is also brittle, at least at room temperature, and the radial crack path through the oxide layer and the outer part of the cladding wall therefore appears characteristically brittle in fractographic examinations of high-burnup fuel rods, which have failed in *RIA* simulation tests, see e.g., the work by Fuketa et al., 2000 or Nakamura et al., 2002a. However, the radial crack path through the innermost part of the cladding wall generally indicates ductile failure, with the fracture surface typically inclined  $45^\circ$  to the main loading (hoop) direction. The ductile feature of the last part of the crack path is usually seen also in highly corroded and embrittled cladding, and it is believed that this inner ductile part of the cladding wall offers significantly higher resistance to the radial crack propagation than the brittle outer part. A typical crack path is shown in Figure 1-13.

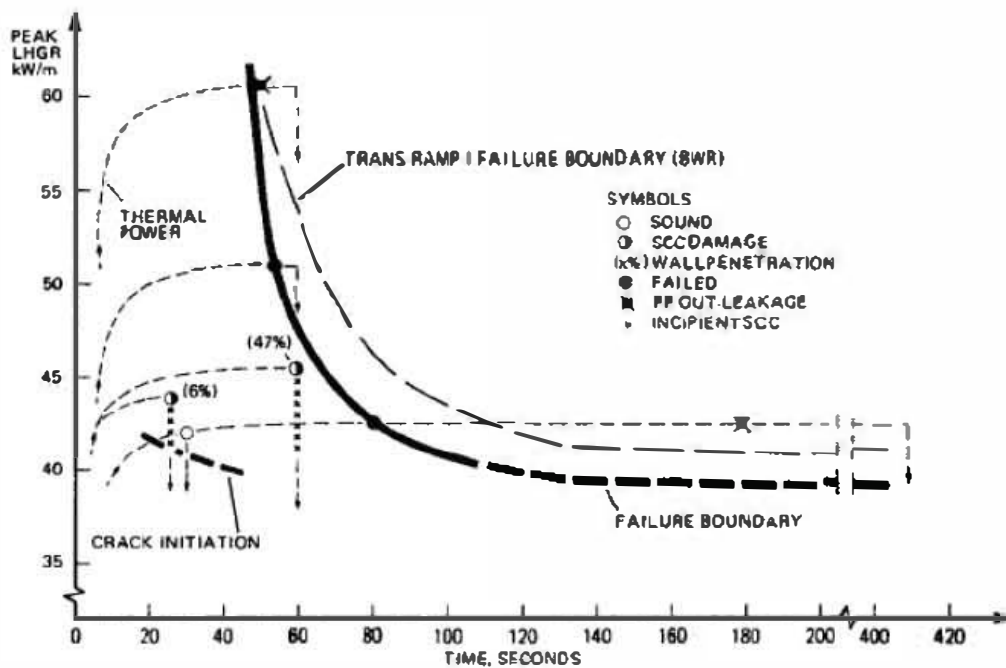
Figure 1-16: TRANS-RAMP II PCIF failure progression, PWR fuel, Mogard et al., 1988.

In ramp tests conducted in test reactors, the ramp rates are higher than those in commercial reactors. Higher ramp rates result in lower *PCI* thresholds since there is less time for stress relaxation. Thus, results obtained from ramp tests in test reactors tend to indicate a conservative *PCI* threshold. In the international ramp tests performed at Studsvik it was shown that a through-wall crack could be obtained in less than one minute, Figure 1-15 and, Figure 1-16. These figures also show that *RIA* transients are too short to be able to produce *PCI* cracks.

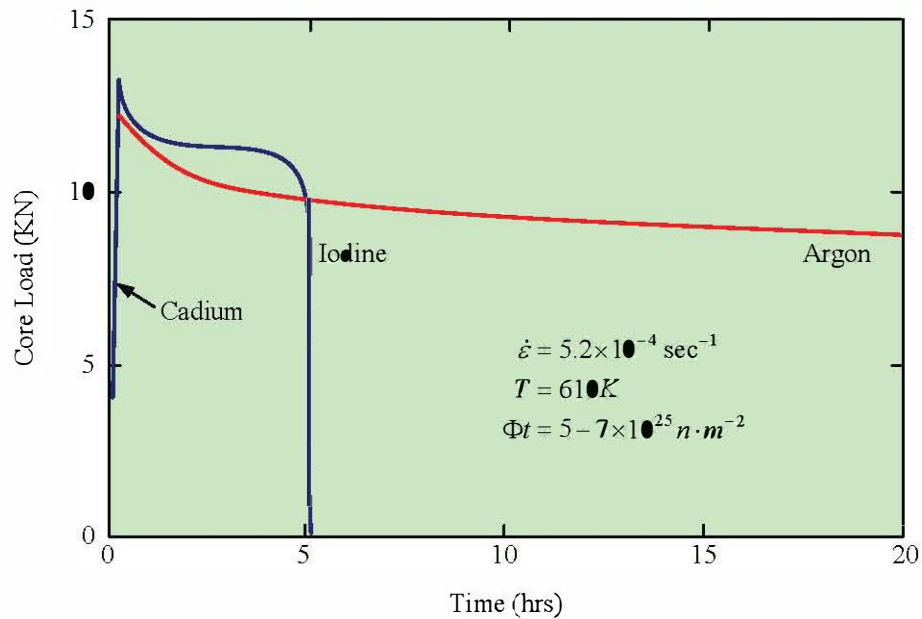
Figure 1-18: Core load (plane strain tests) versus time for ramp and hold, *RH*, expanding mandrel irradiated Zircaloy-2 tubes tested in argon, iodine (gas), and cadmium (liquid) at 610 K, modified figure according to Wisner & Adamson, 1982.

Figure 1-17 and Figure 1-18 shows the effect of Cs, Cd and Iodine on the SCC tendency of Zircaloy, see Section 2.1.2 for more details.

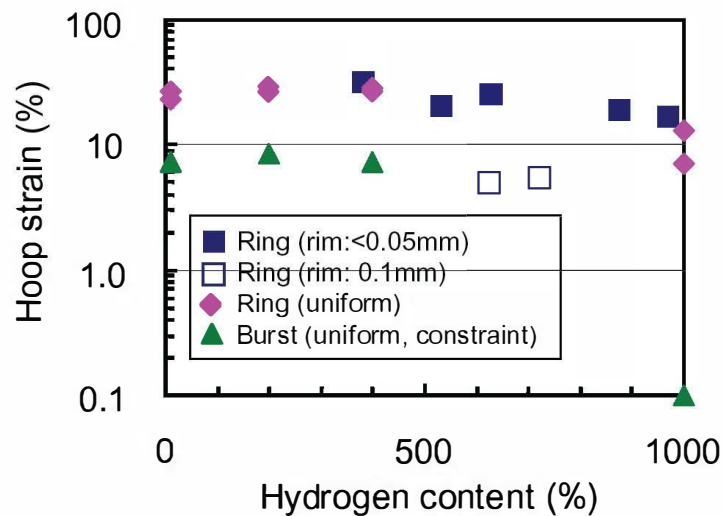
Figure 1-19: Cladding hoop strains at failure in ring tensile tests and residual hoop strains in burst tests of pre-hydrated *PWR* cladding, Nakamura et al., 2003(a).

These results indicate that the stress state has a dramatic impact on cladding ductility. The implication of these results is that to obtain relevant data it is crucial that the stress state in an *RIA* simulation test is similar to that during an *RIA*, i.e.,
